**ON-SITE AIR BAG INVESTIGATION**

CASE NO. - 96-05  
FLEET - PRIVATE VEHICLE  
LOCATION -  
ACCIDENT DATE - 1996

Case Vehicle: 1995 Volkswagen Golf III City, Five-door Hatchback

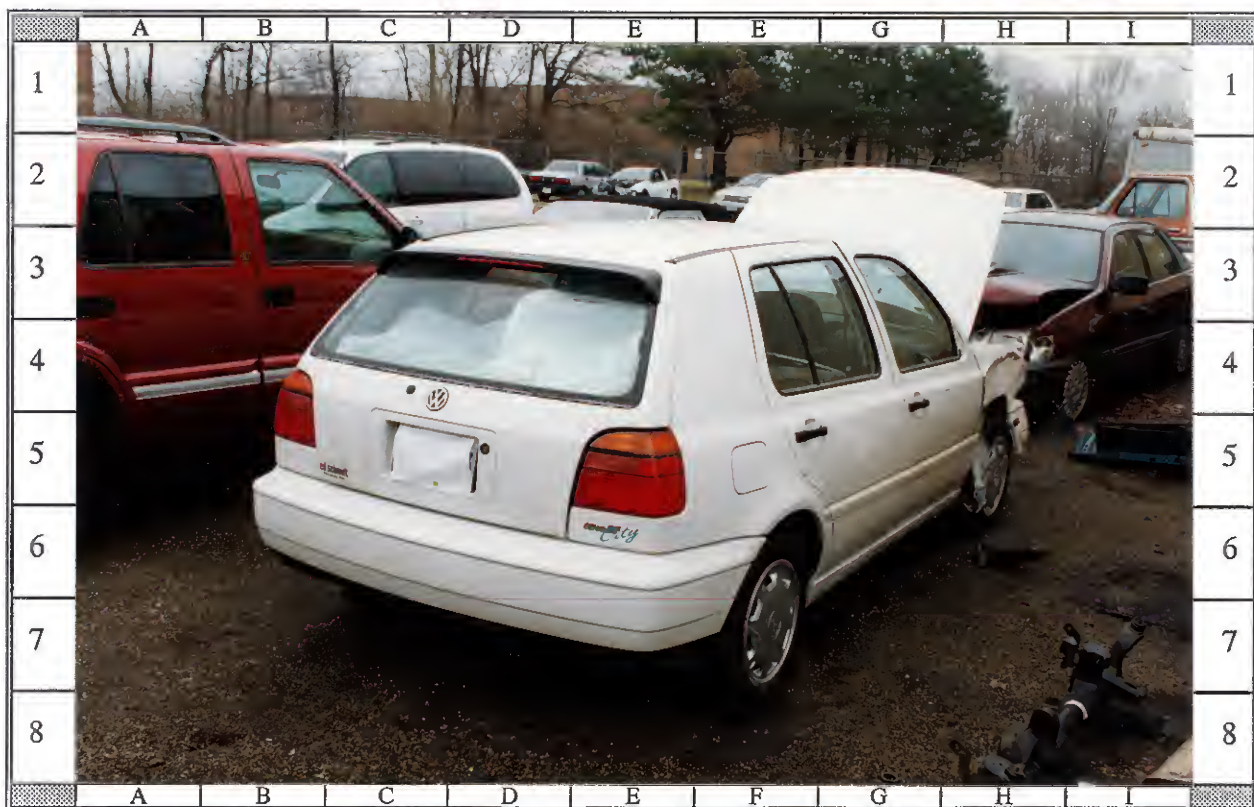
# 22: Case Vehicle's undamaged back and right rear side viewed from approximately 45 degrees right of back

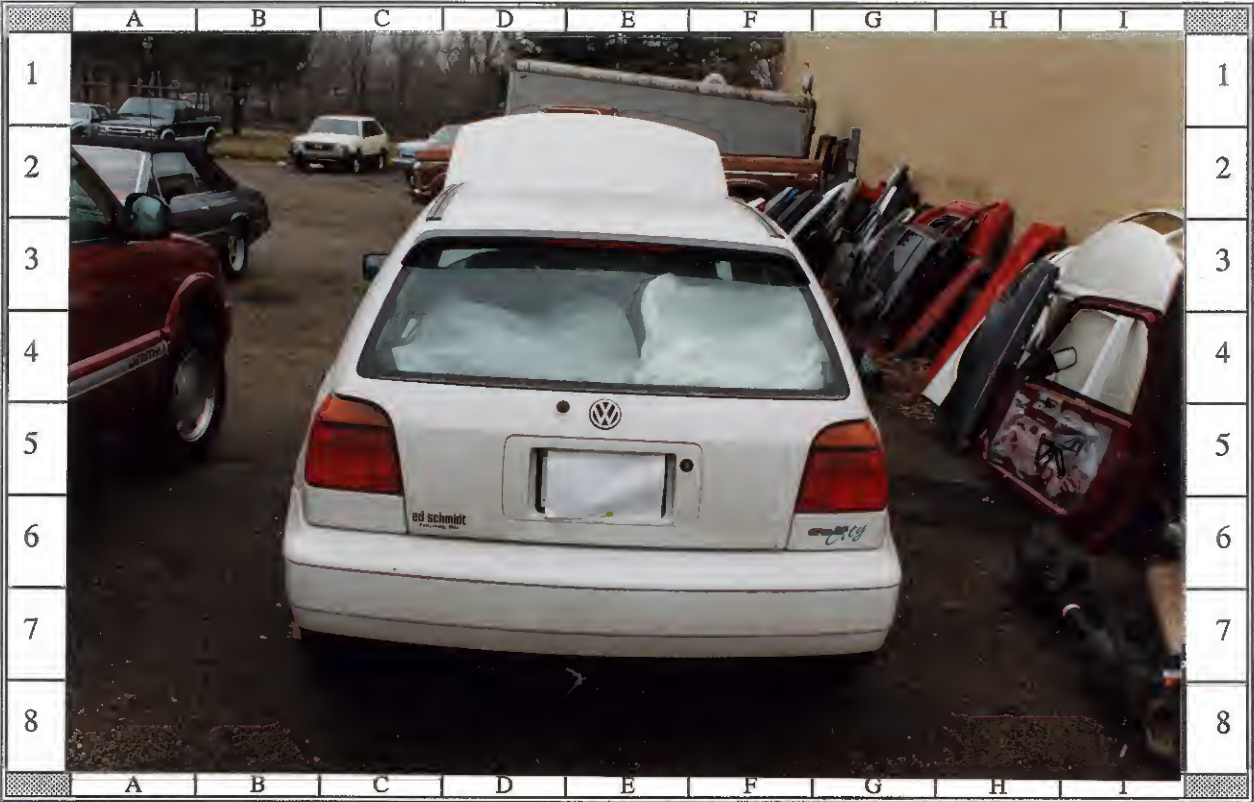
# 23: Case Vehicle's undamaged back plane; NOTE: driver and right front passenger air bag modules are shown in rear hatch area after removal

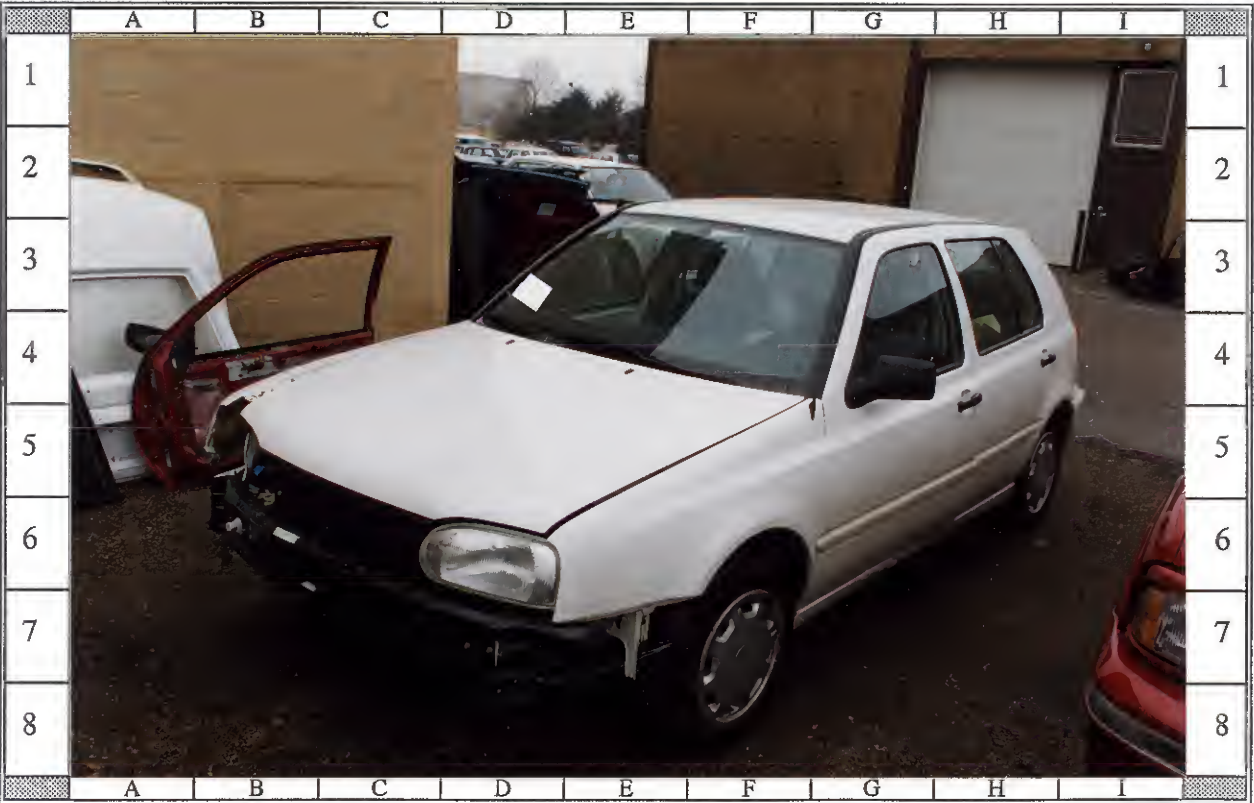
# 24: Case Vehicle's dismantled front end and undamaged left side viewed from approximately 45 degrees left of front

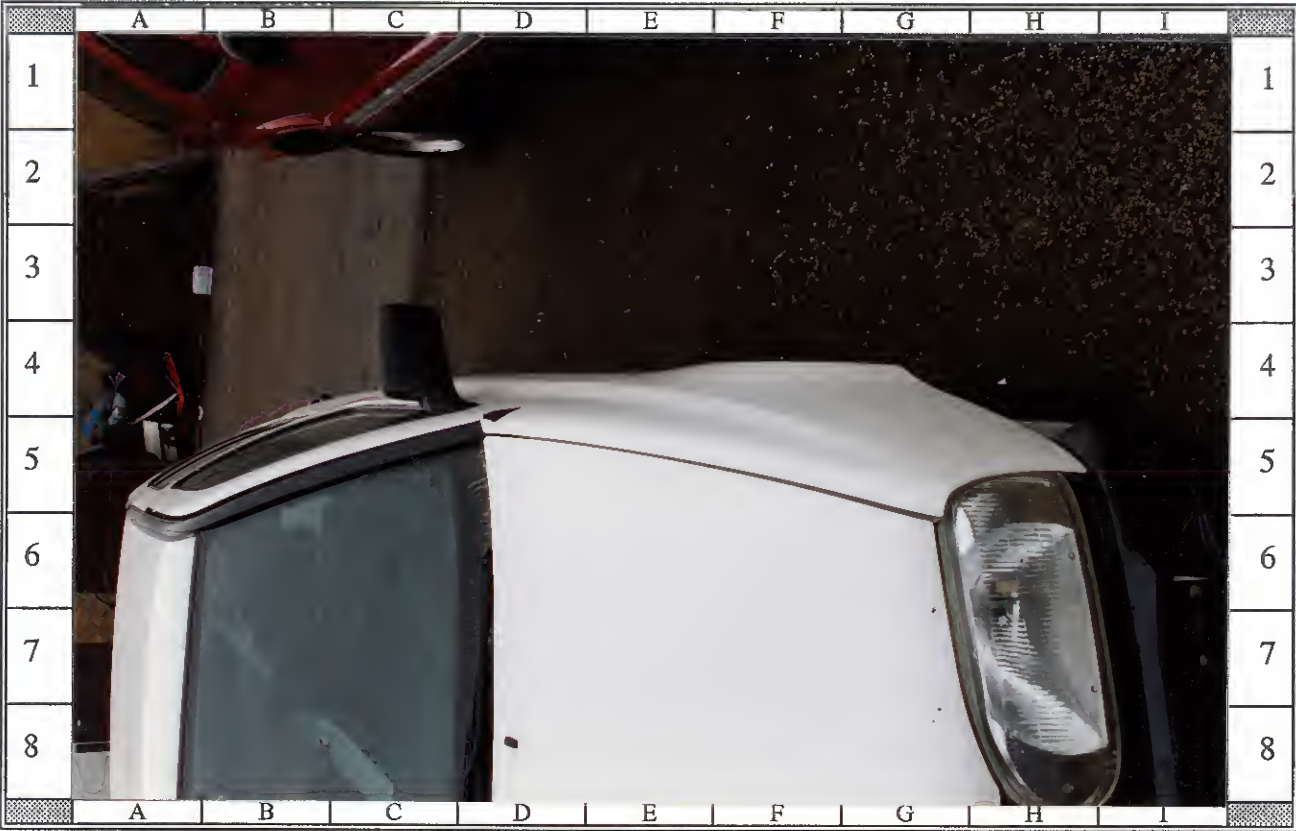
# 25: Case Vehicle’s undamaged left side shown from front to back along left reference line

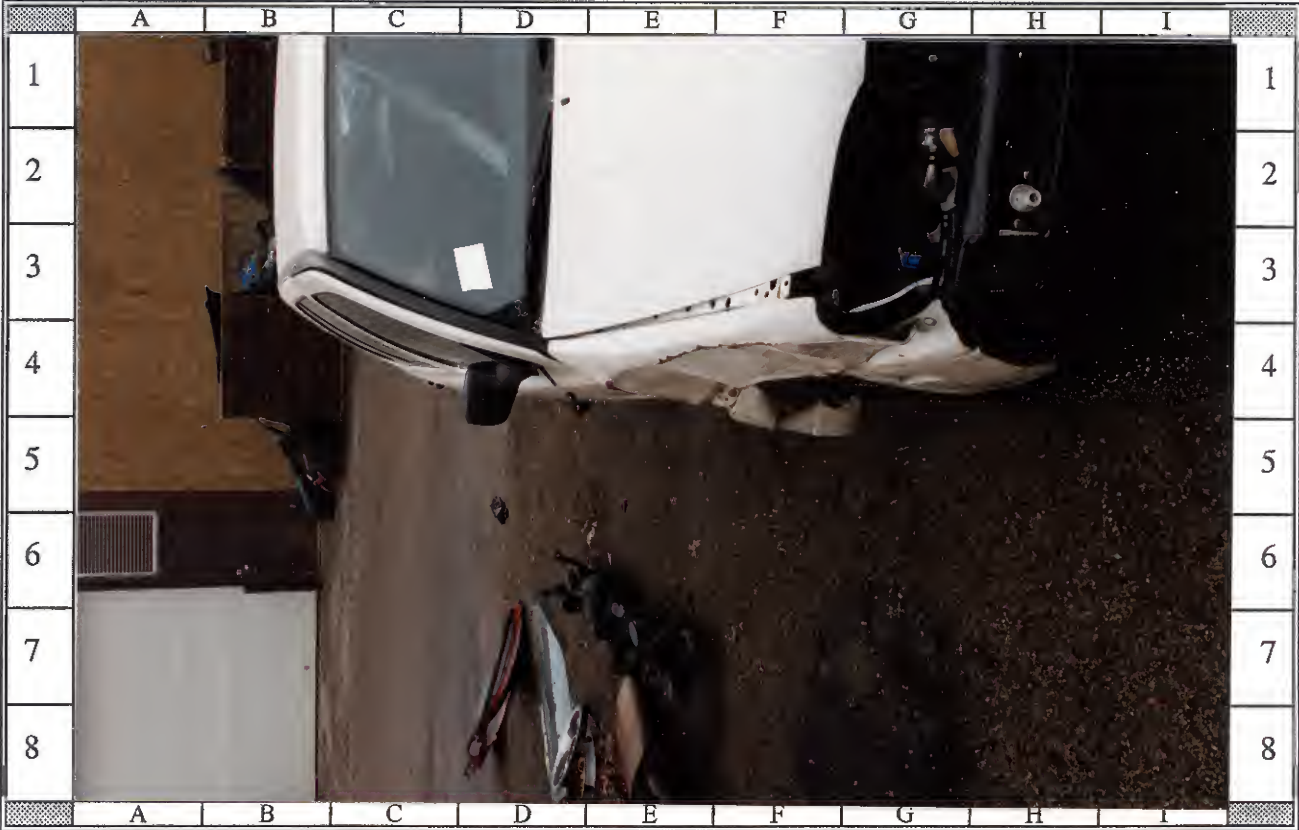
# 26: Case Vehicle’s damaged right side shown from front to back along right reference line; NOTE: sideswipe type damage

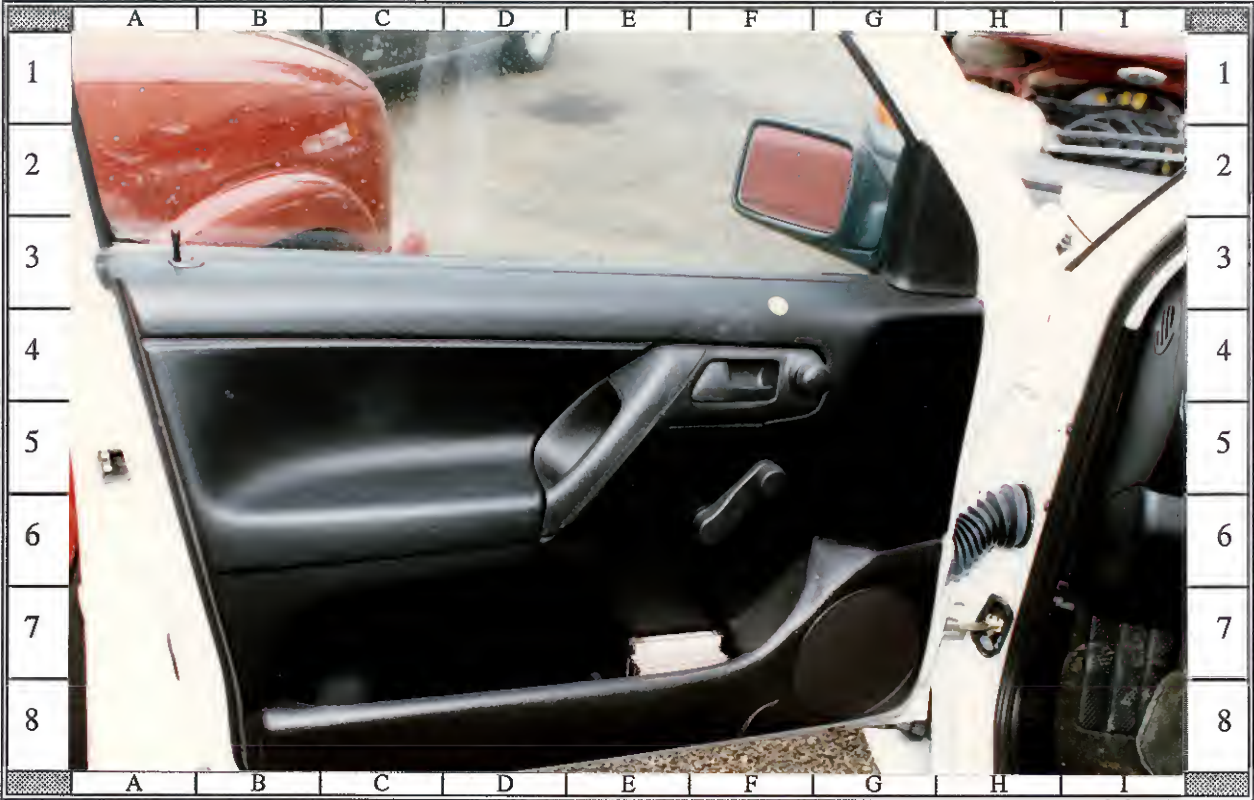
# 27: Case Vehicle's driver door viewed while open from back showing smudge, of unknown origin, to interior surface (cells F3--F4)

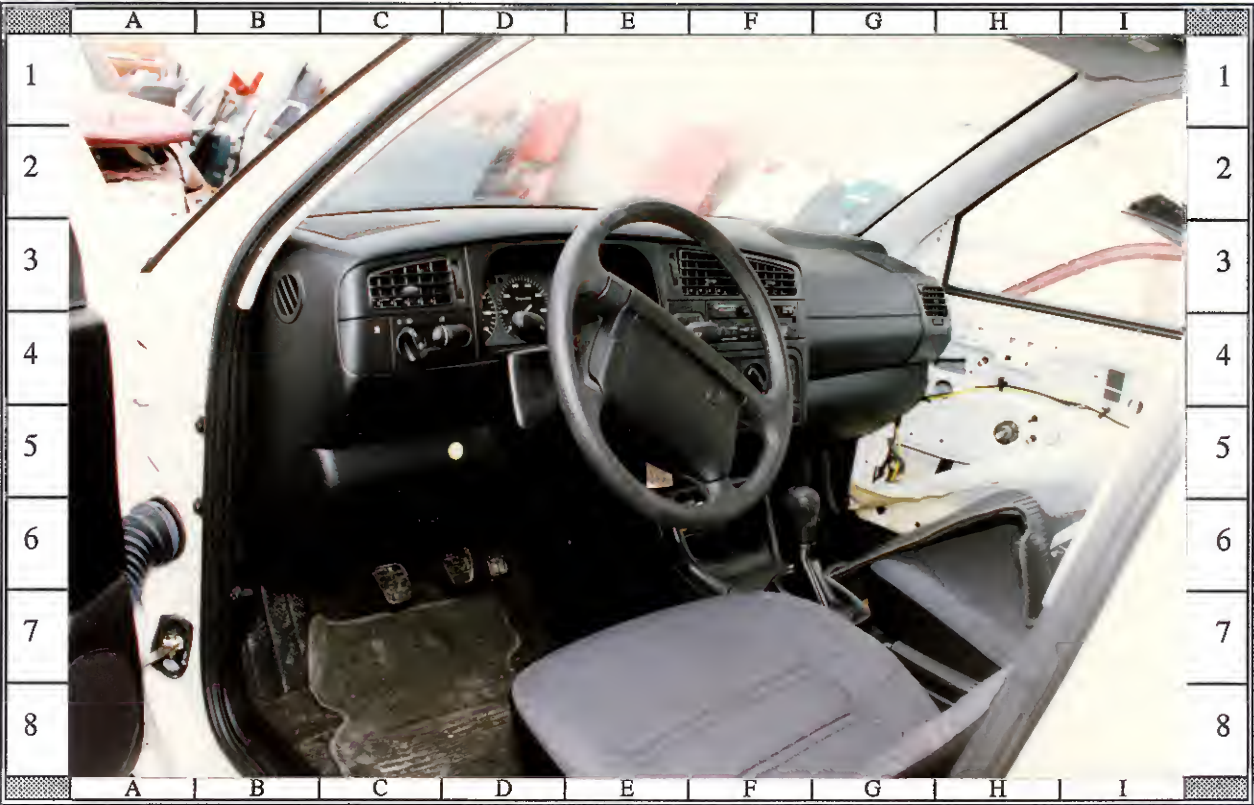
# 28: Case Vehicle's front seating area showing replaced driver and passenger air bag modules; NOTE: evidence of contact on knee bolster from left knee

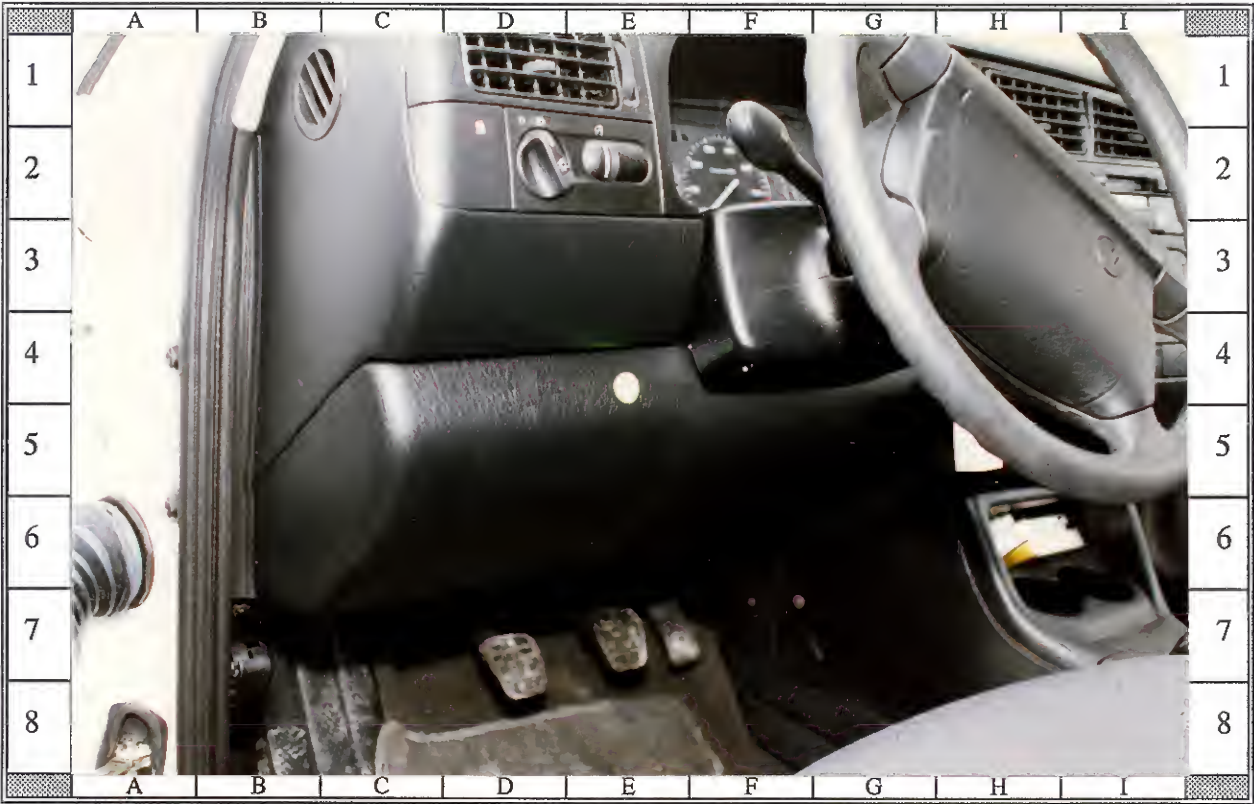
Damaged Components:	Steering wheel rim, and air bag
Other Evidence of Occupant Contact:	Driver's knee bolster

# 29: Close-up of contact to Case Vehicle's knee bolster caused by driver's left knee

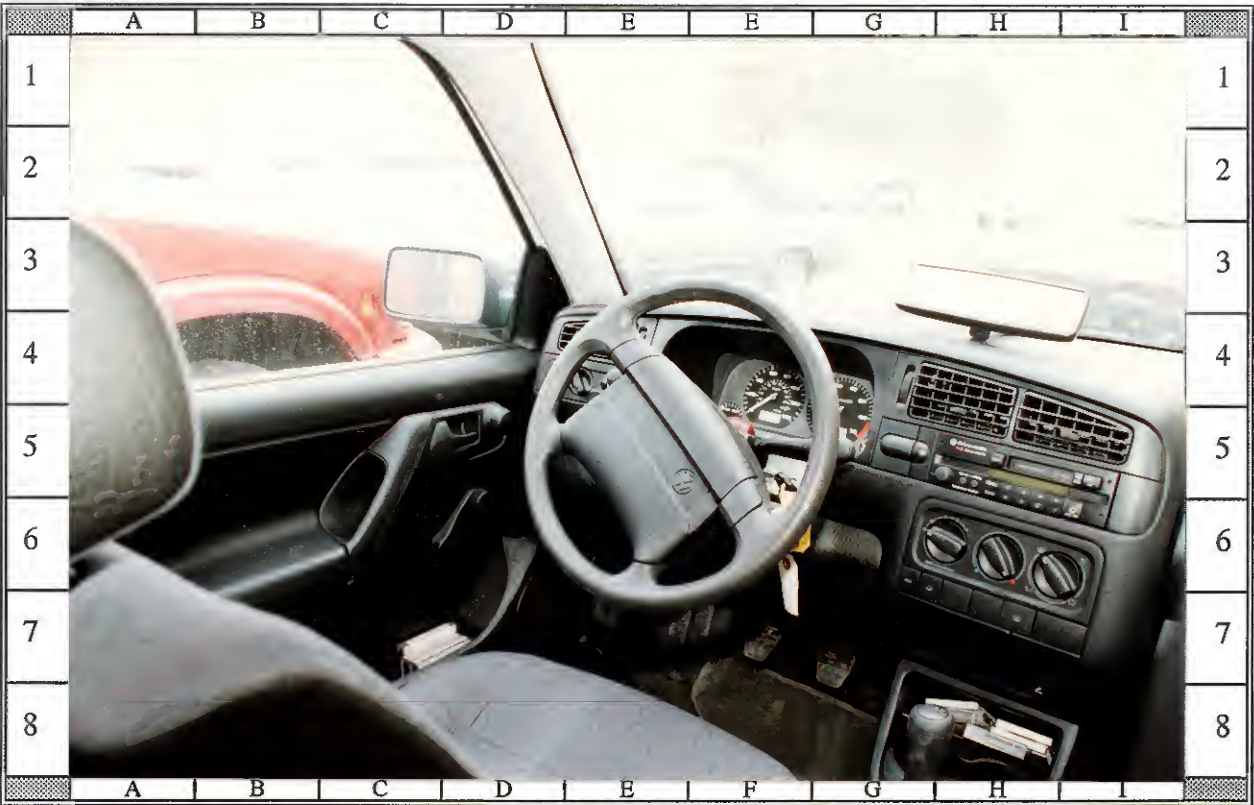
# 30: Case Vehicle's driver seating area showing replaced driver air bag module and noncontacted center console and left A-pillar; NOTE: rearview mirror atop dash

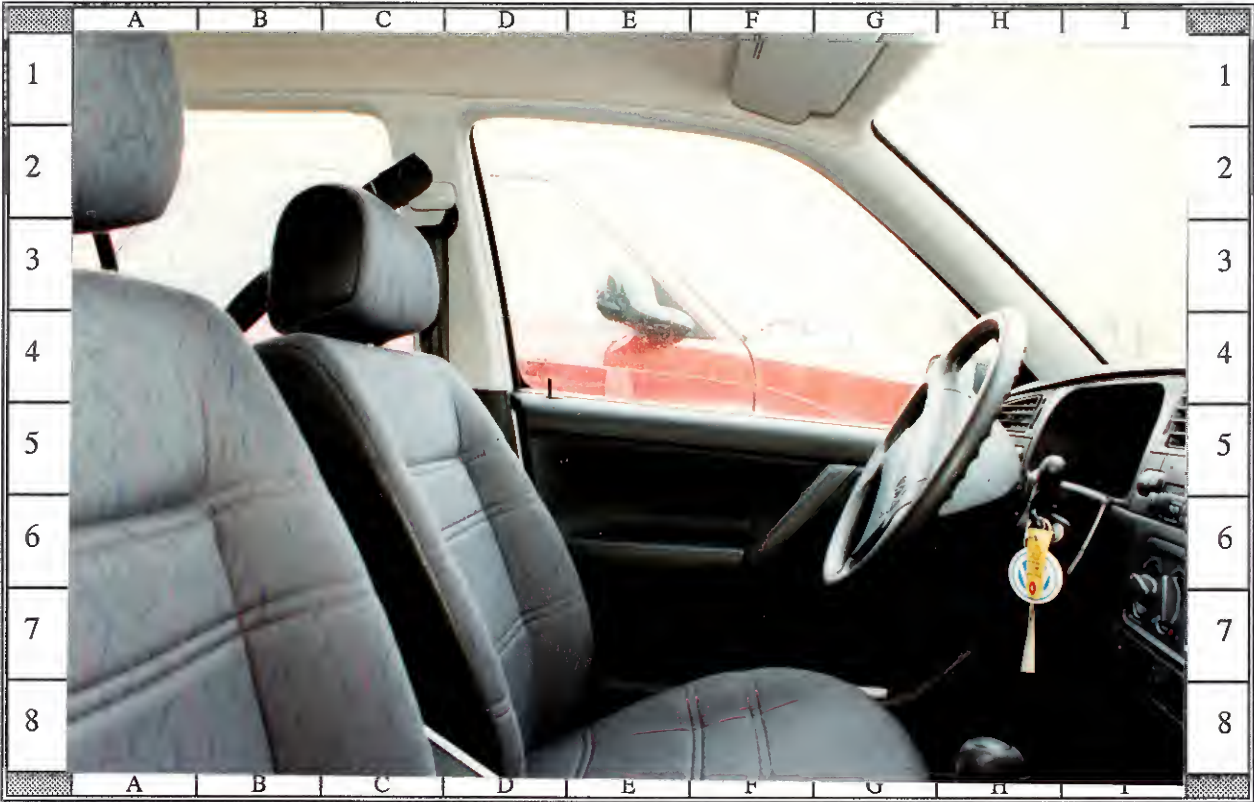
# 31: Case Vehicle's driver seating area; NOTE: replaced air bag module, noncontacted left pillars and roof side rail, and adjustable shoulder harness on B-pillar

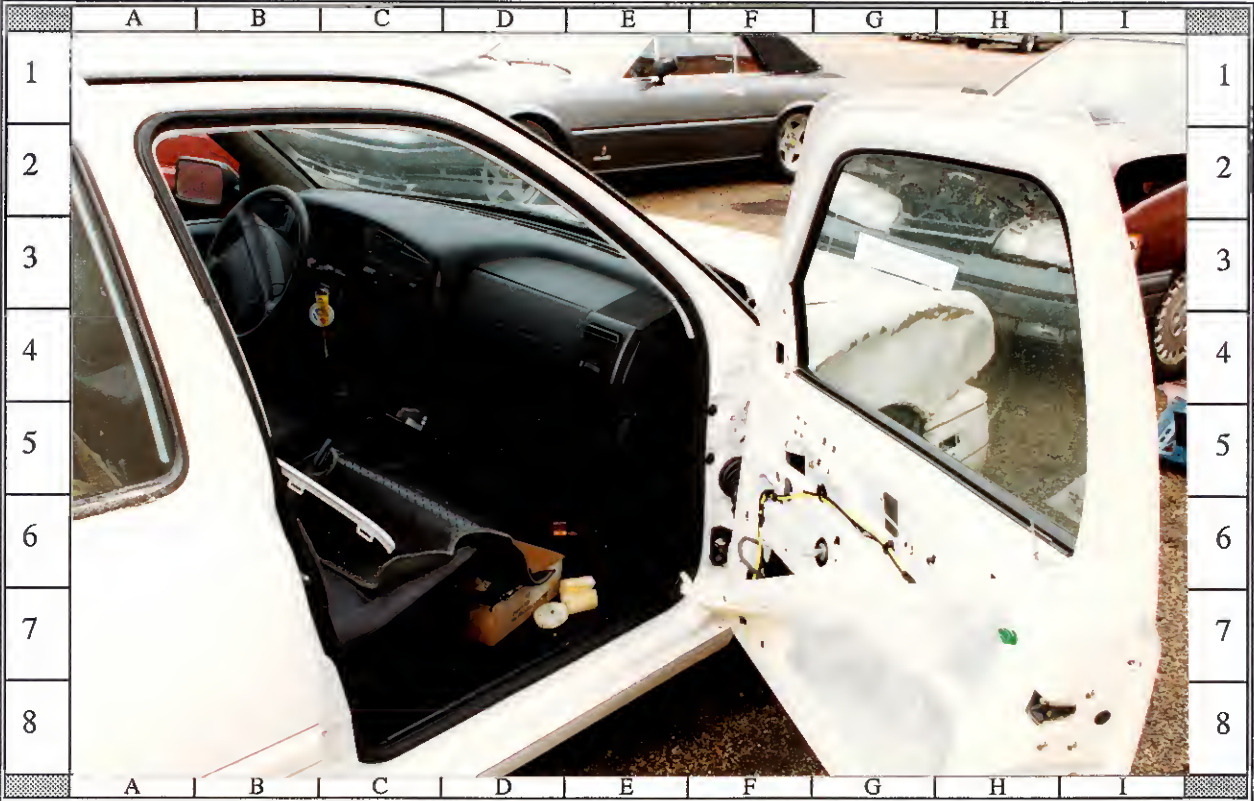
# 32: Case Vehicle's right front passenger seating area and door; NOTE: replaced air bag modules and interior door panel removed for repair

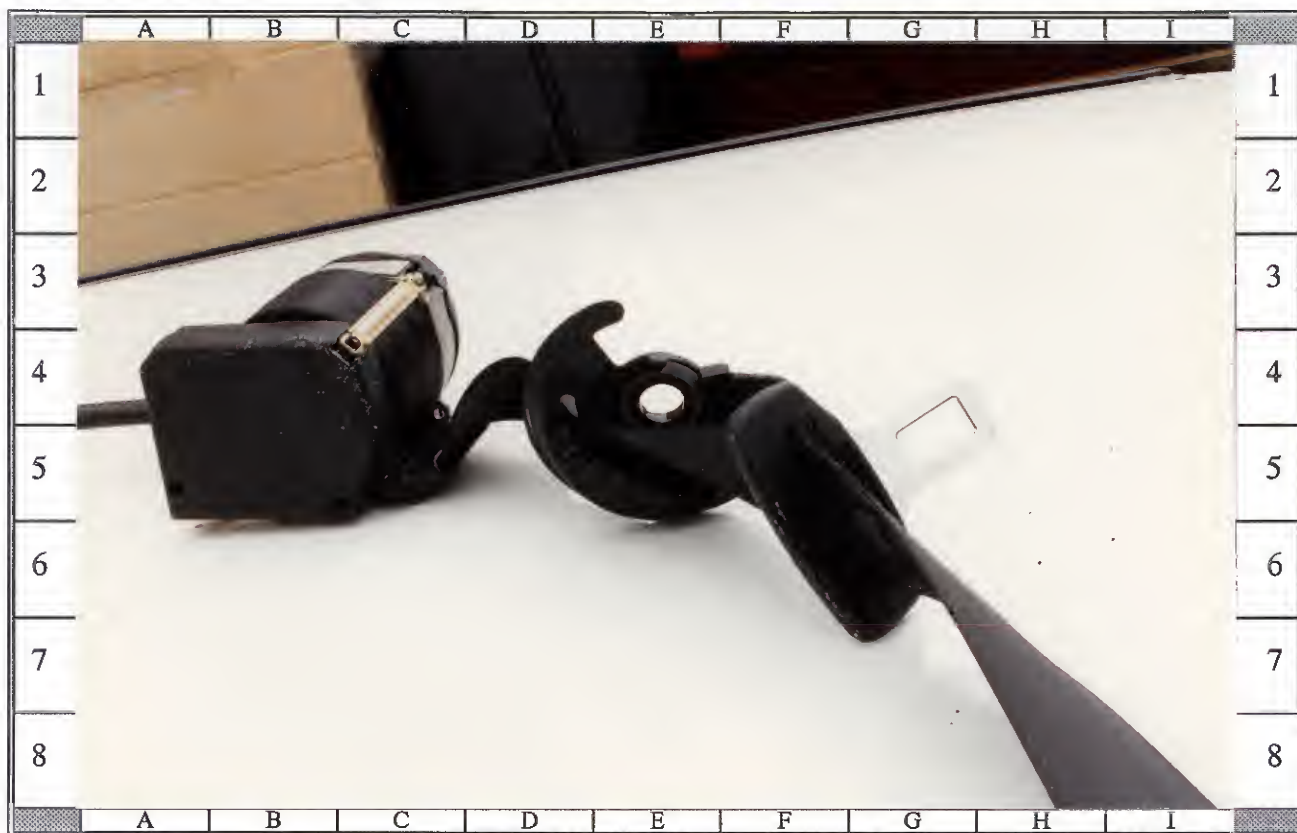
# 33: Case Vehicle's removed driver seatbelt--a normal Volkswagen practice following crashes; NOTE: no evidence of usage found on belt or D-ring

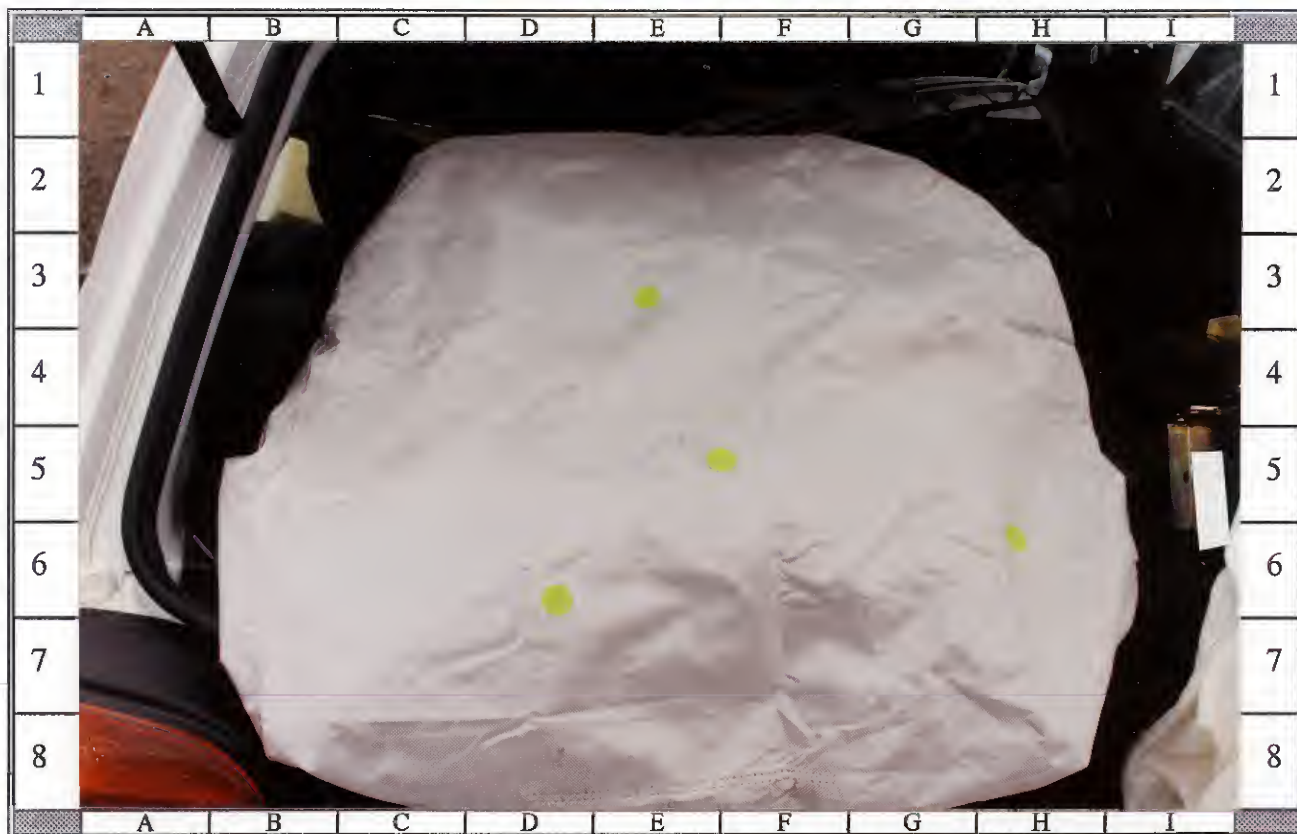
# 34: View of marks and contact evidence to Case Vehicle's driver air bag; NOTE: air bag located in hatch and green dots represent marks and contacts

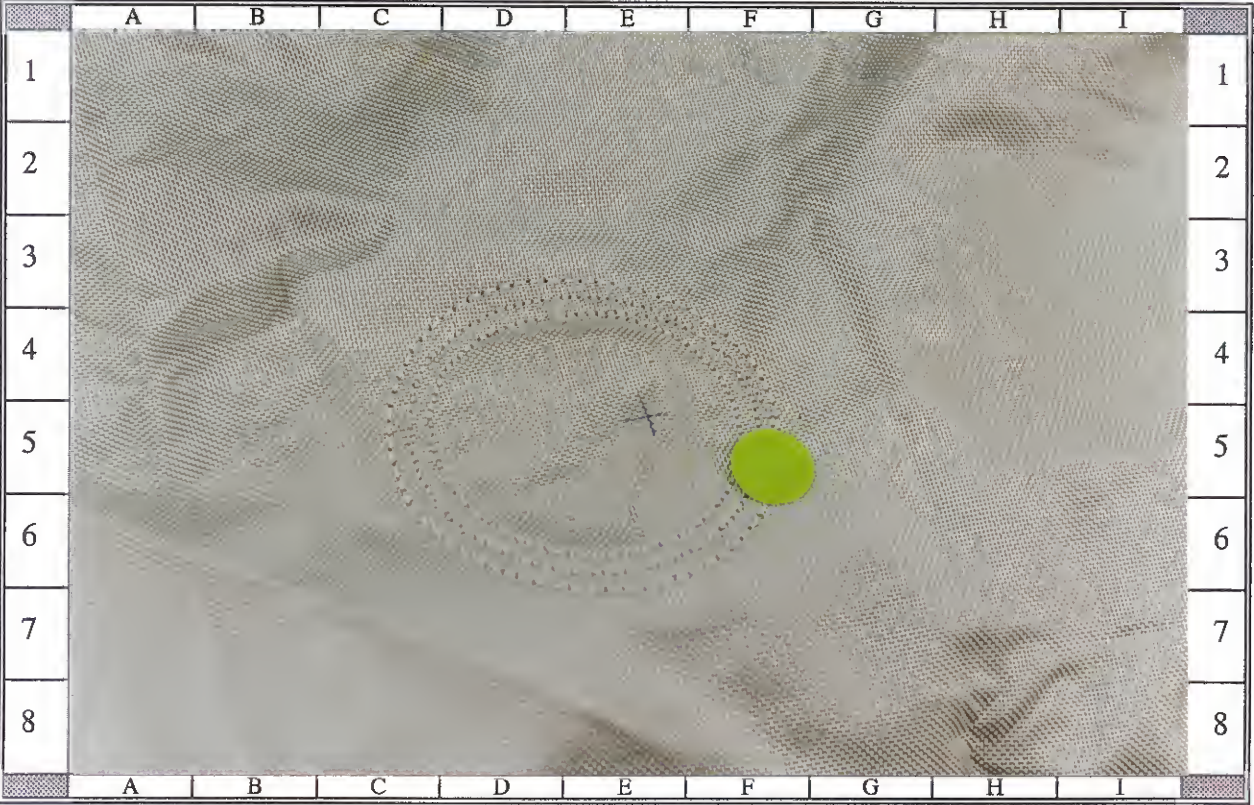
# 36: Close-up of Case Vehicle's driver air bag showing facial contact to center portion of air bag; NOTE: contact appears to be lipstick

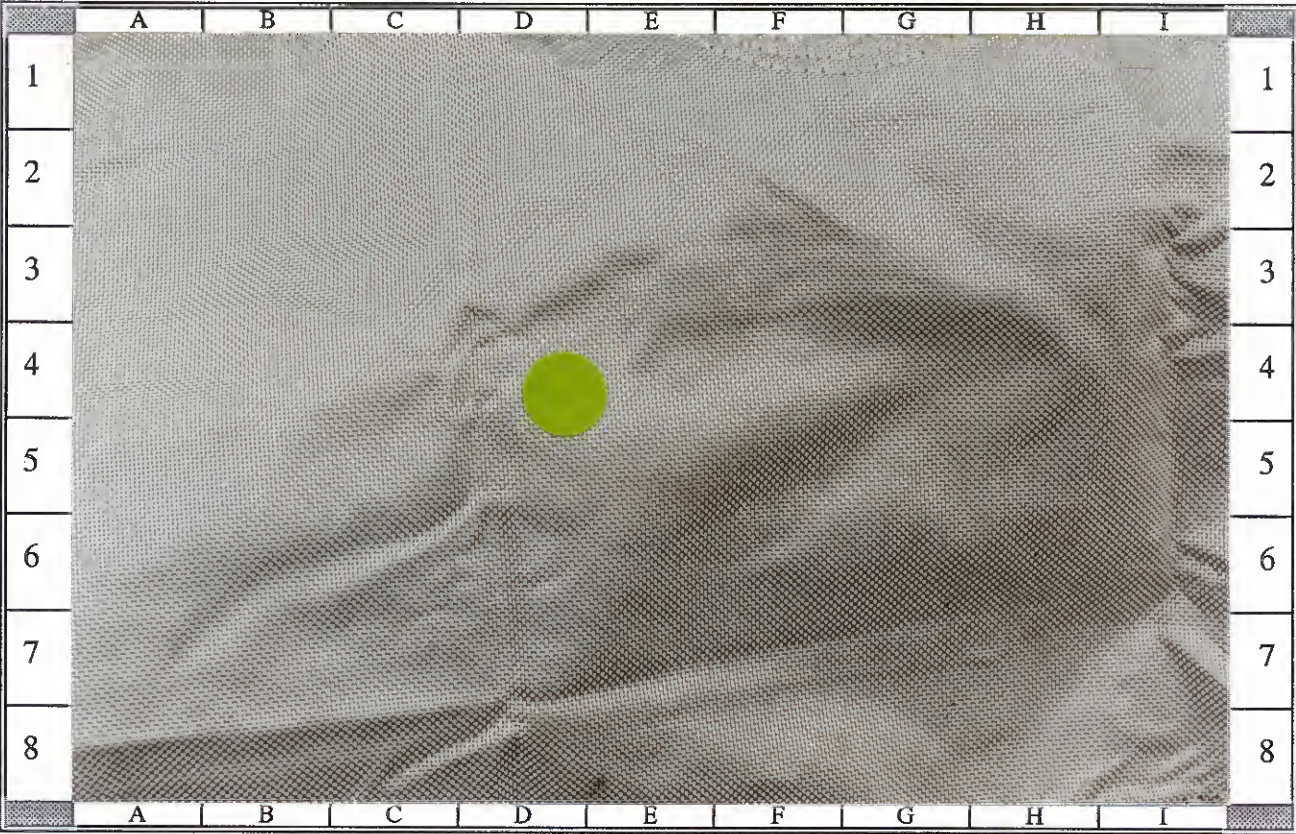
# 37: Close-up of Case Vehicle’s driver air bag showing an unknown mark on lower left of air bag; NOTE: mark is possibly an oil smear

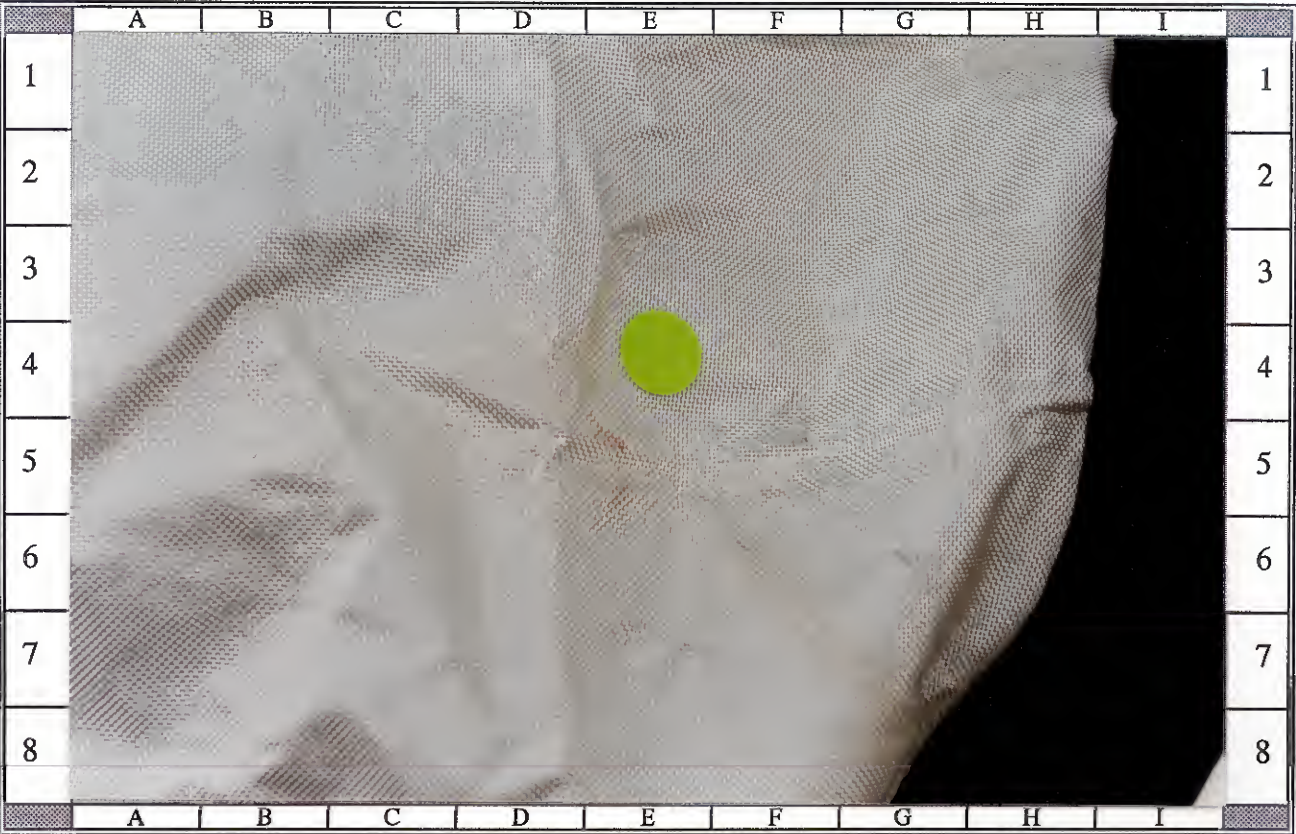
# 38: Close-up of Case Vehicle’s driver air bag showing an unknown mark to right side of air bag; NOTE: mark is possibly smeared blood or make-up

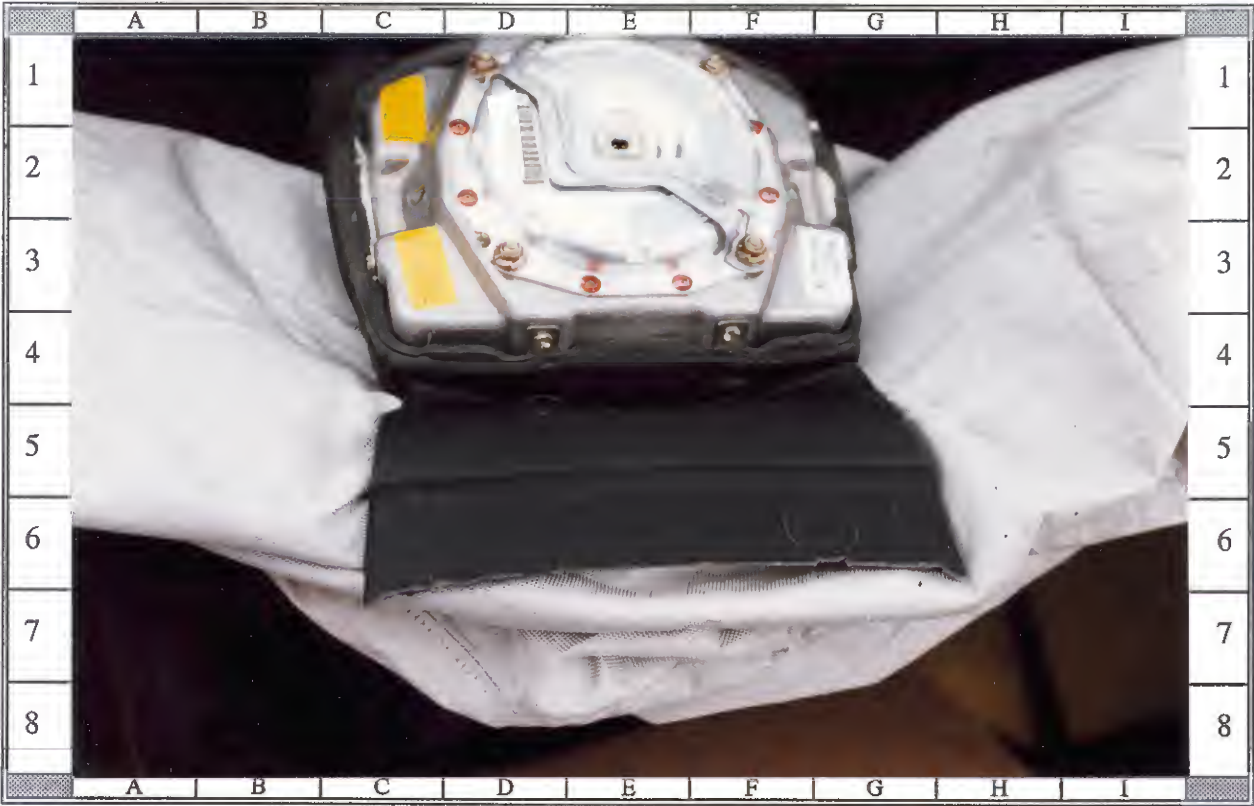
# 39: Close-up of top cover flap from Case Vehicle's driver air bag module showing no contact evidence; NOTE: backside of module shown above flap

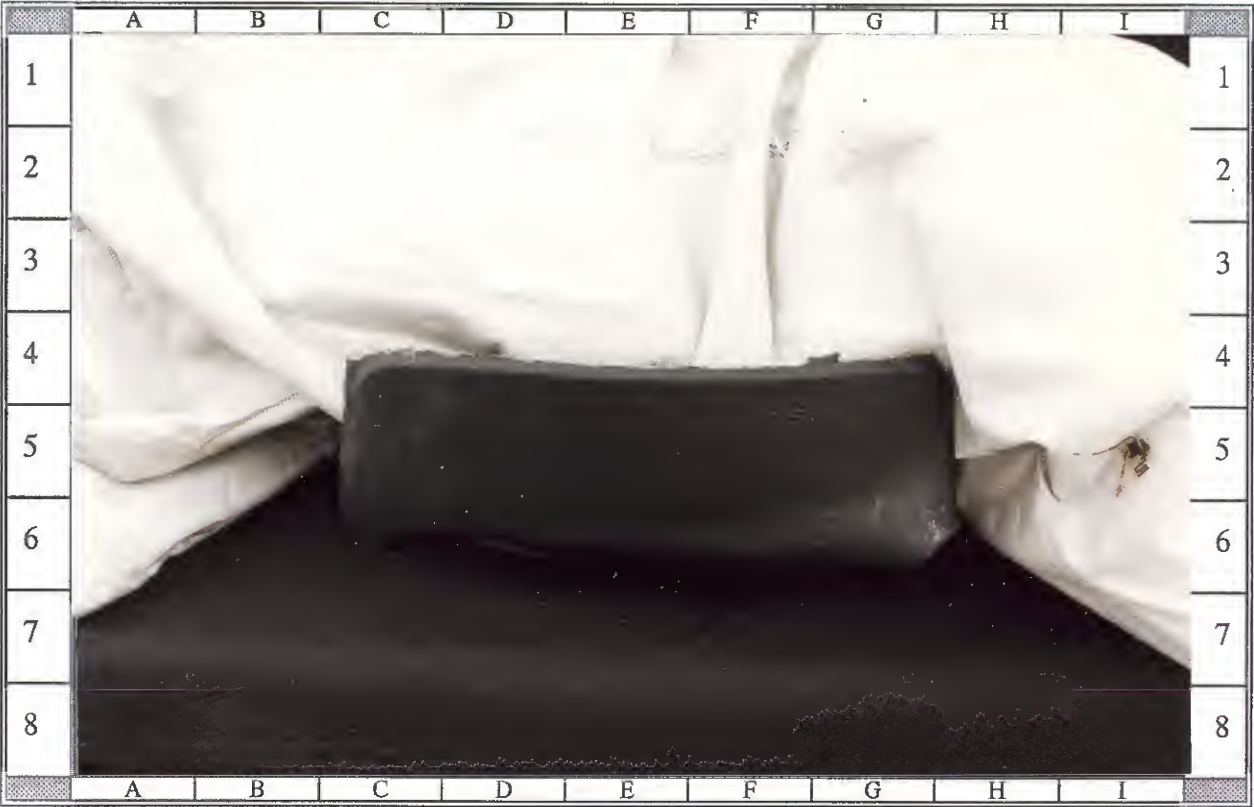
# 40: Close-up of bottom cover flap from Case Vehicle's driver air bag module showing no contact evidence

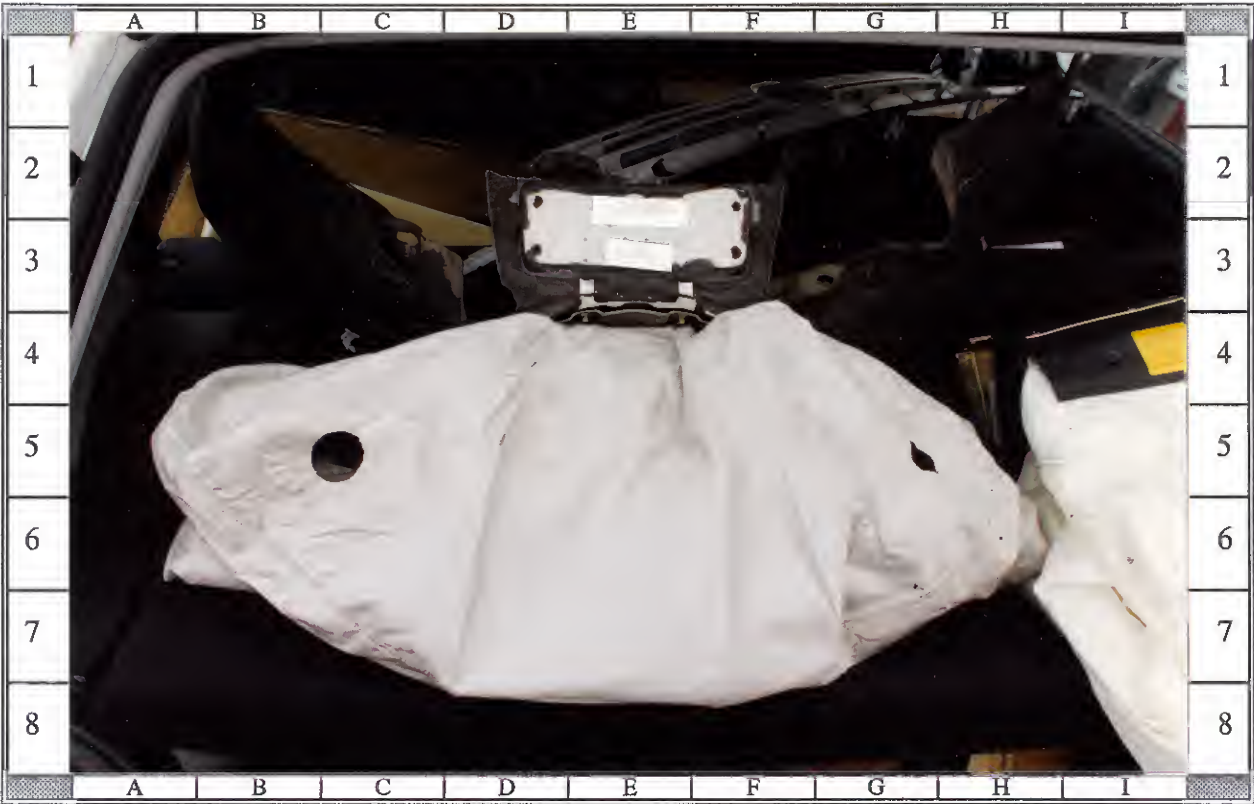
# 41: Close-up of vent holes--near Ten and Two o'clock, on Case Vehicle's driver air bag; NOTE: removed air bag module was located in hatch at time of photograph

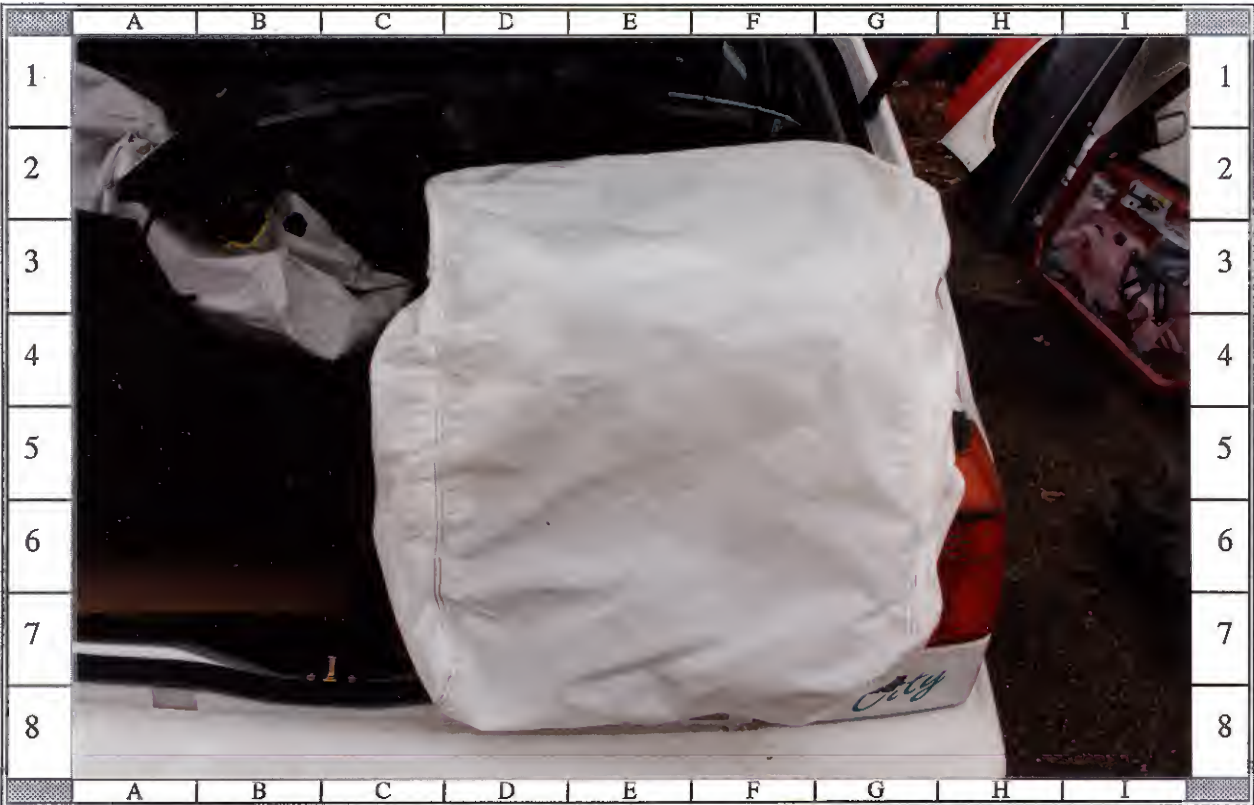
# 42: Case Vehicle's noncontacted right front passenger air bag; NOTE: removed air bag module was located in hatch at time of photograph

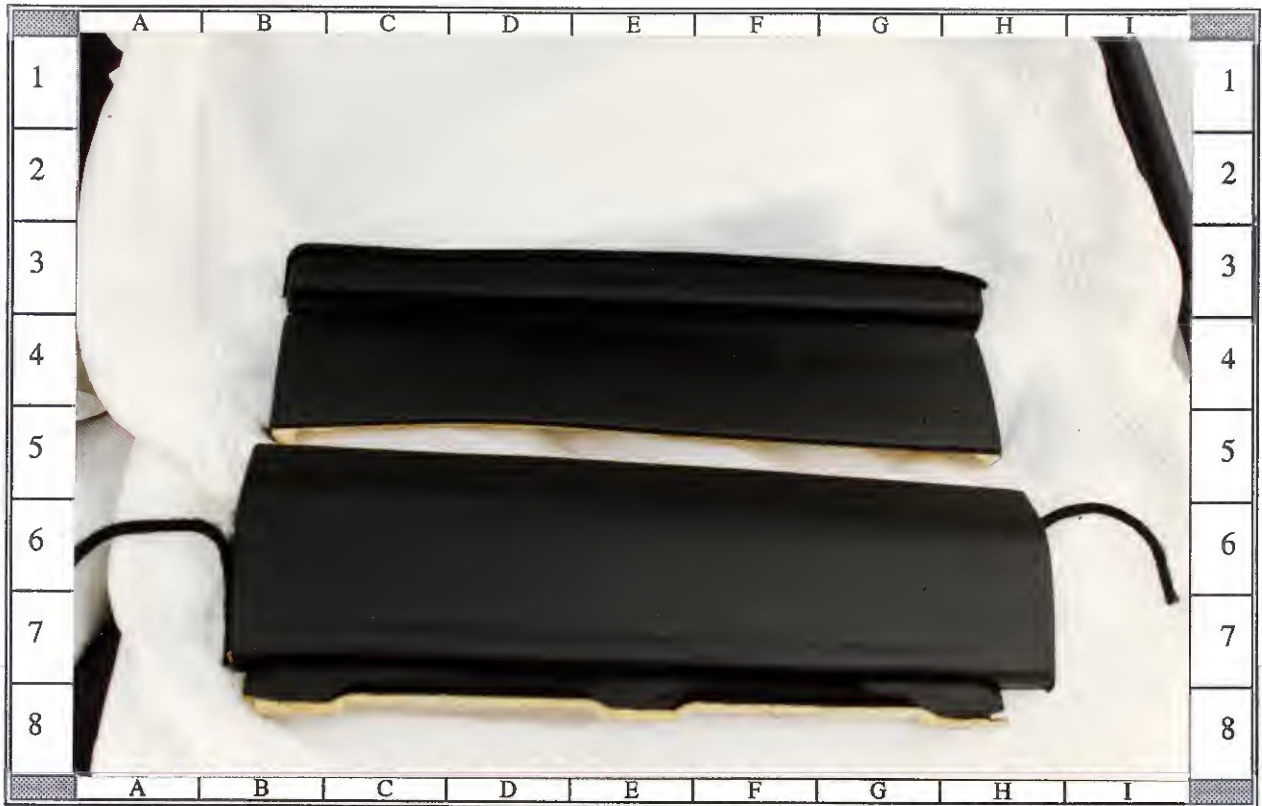
# 43: Close-up of noncontacted top and bottom cover flaps from Case Vehicle's right front passenger air bag; compare flap alignment with Photos #28 and #32
